# **CHARTER TOWNSHIP OF OSHTEMO SANITARY SEWER EVALUATION**

October 27, 2020

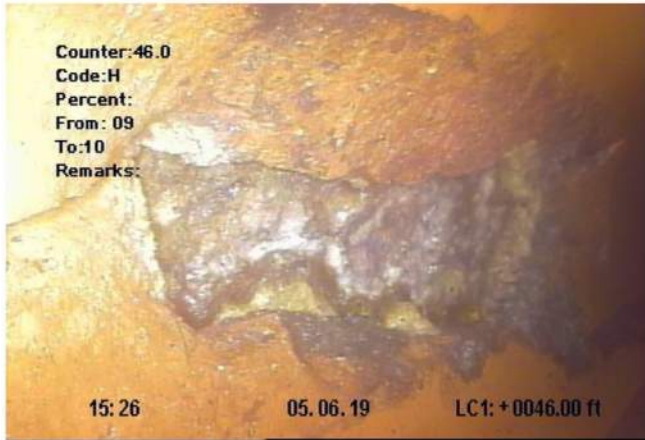
Broken Pipe – 295' Downstream MH 06208  
9<sup>th</sup> Street

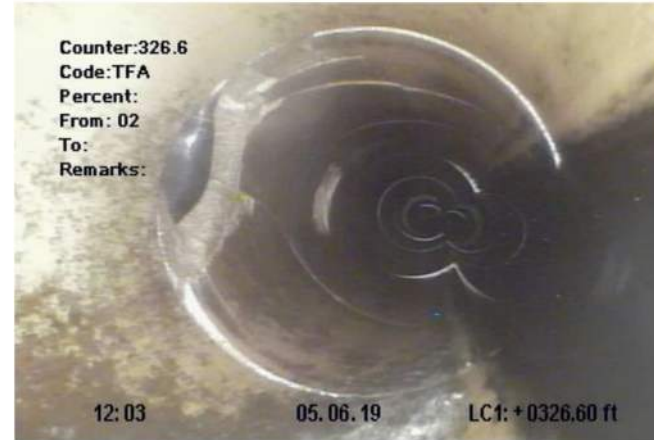
Broken Pipe – 328' Downstream MH 06231  
9<sup>th</sup> Street

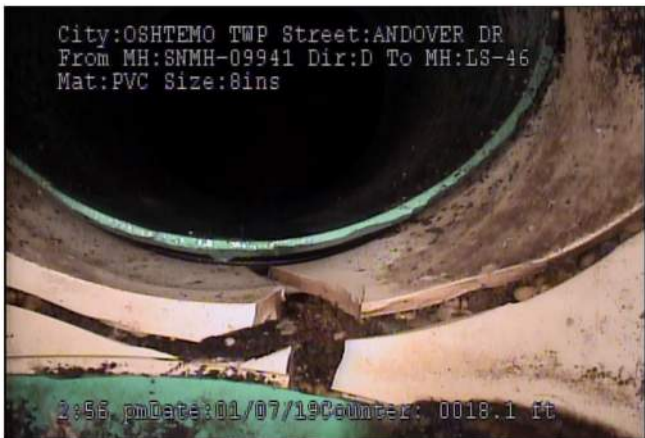
Broken Pipe – 18' Downstream MH 09941  
Andover Drive

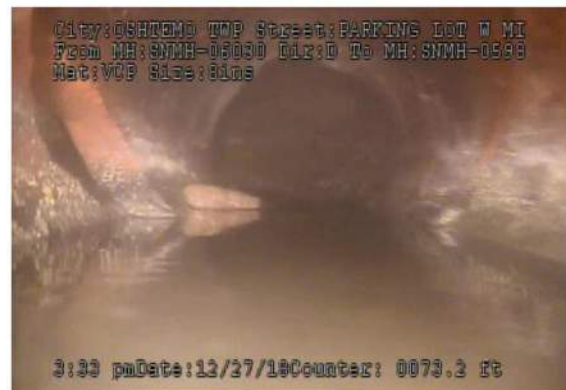
Broken Pipe – 73' Downstream MH 06030  
11<sup>th</sup> Street

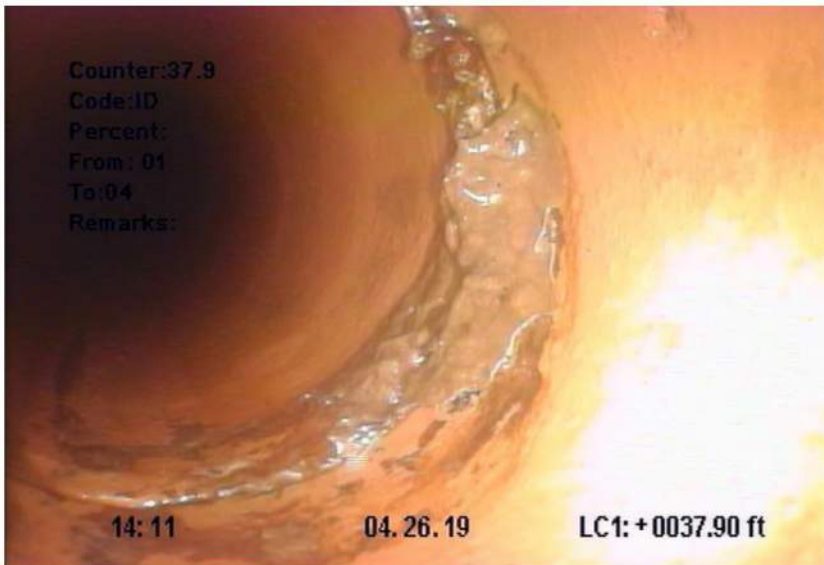
Infiltration Dripper – 38' Downstream MH 06000  
West Main Street

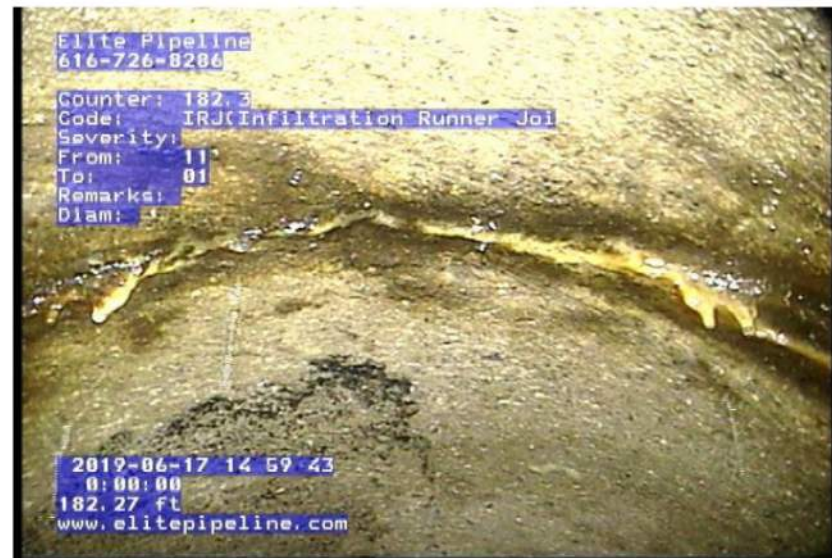
Infiltration Runner – 272' Downstream MH 05718  
W KL Avenue

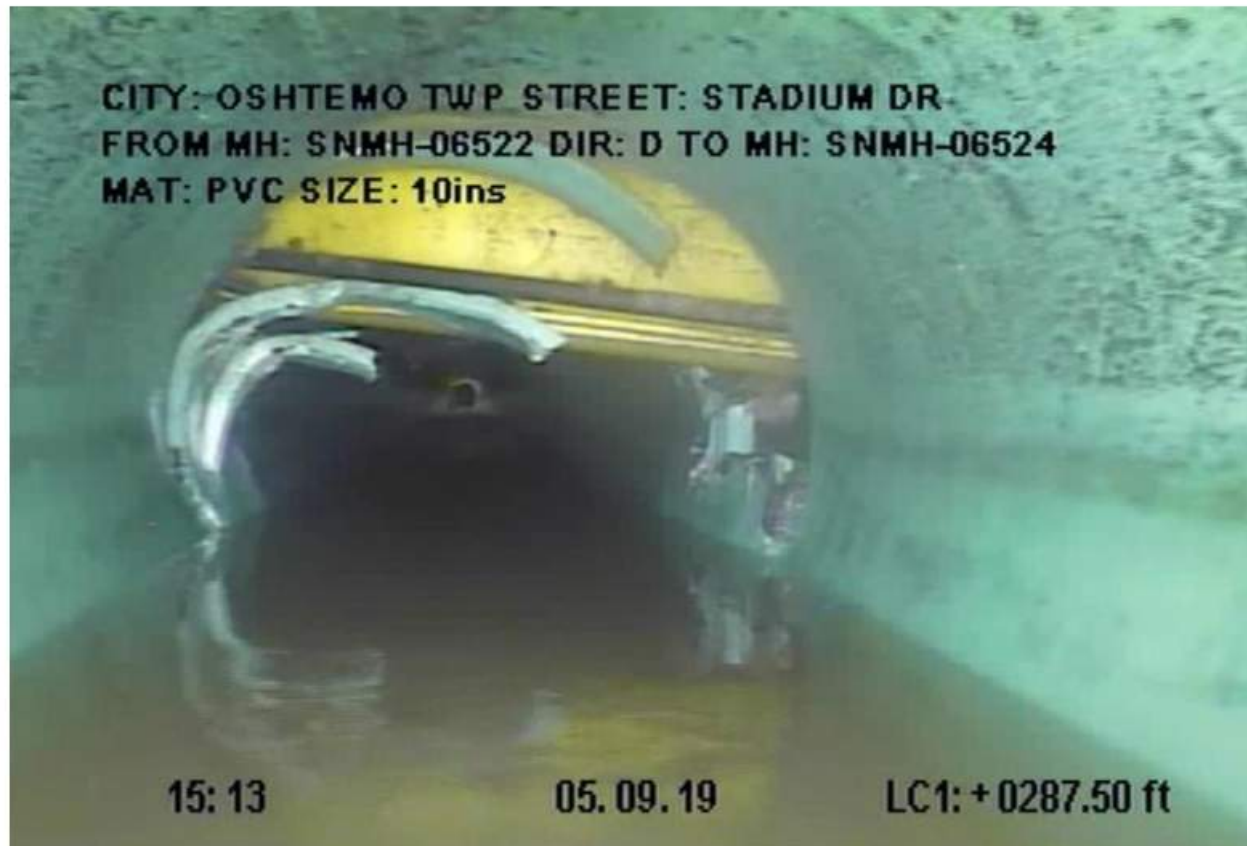
External Utility Penetration – 288' Downstream MH 06522  
Stadium Drive

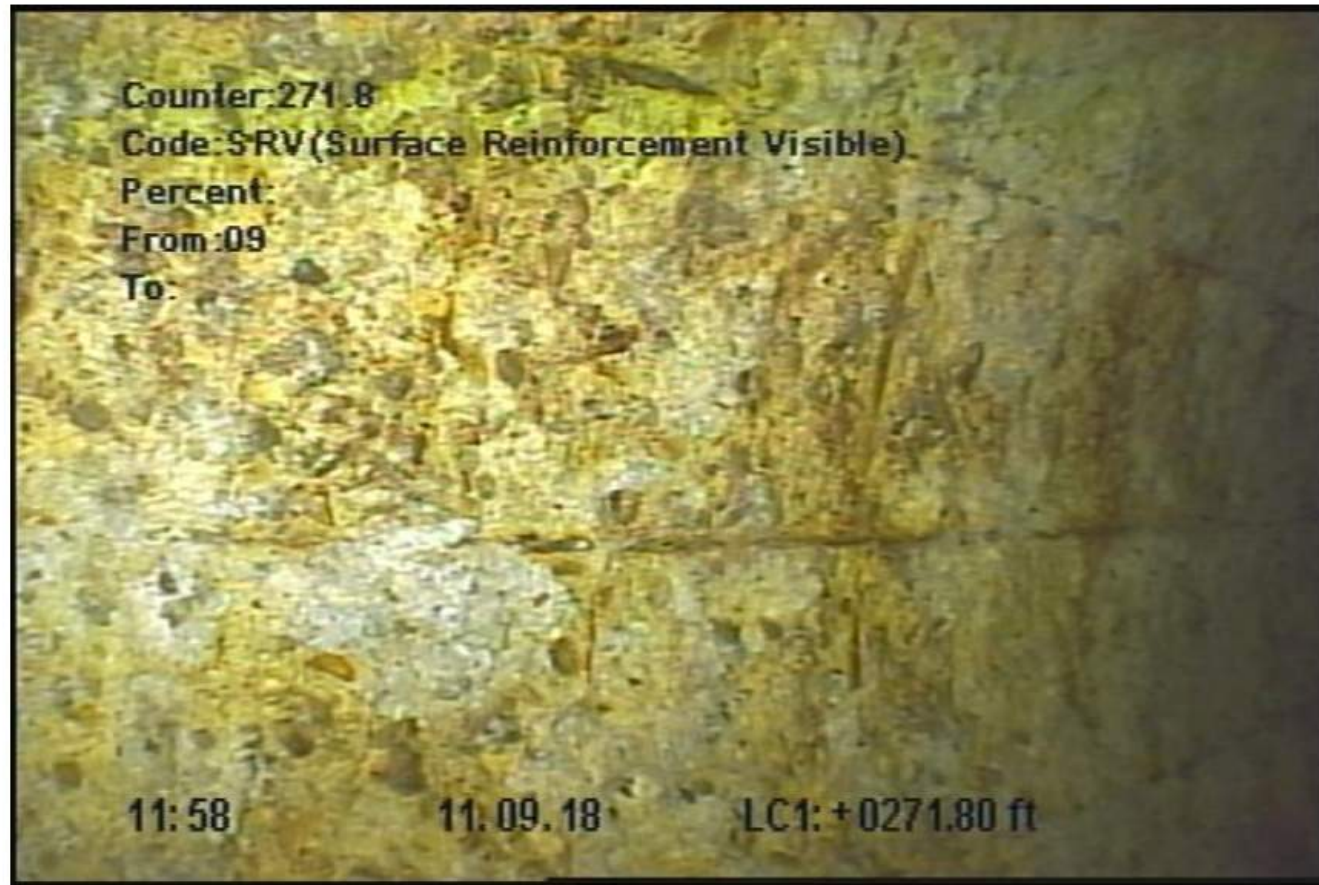
Surface Reinforcement Visible – 13' Downstream MH 05990  
Antiqua Circle

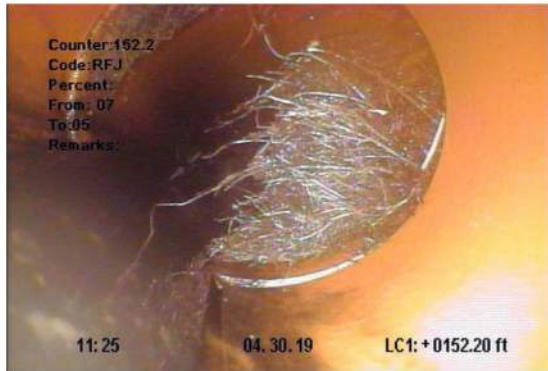
Roots (Fine Joint) – 152' Downstream MH 06071  
Drake Road

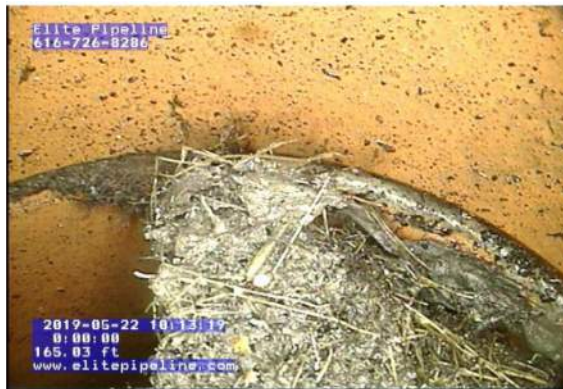
Roots (Joint) – 170' Downstream MH 05654  
Drake Road

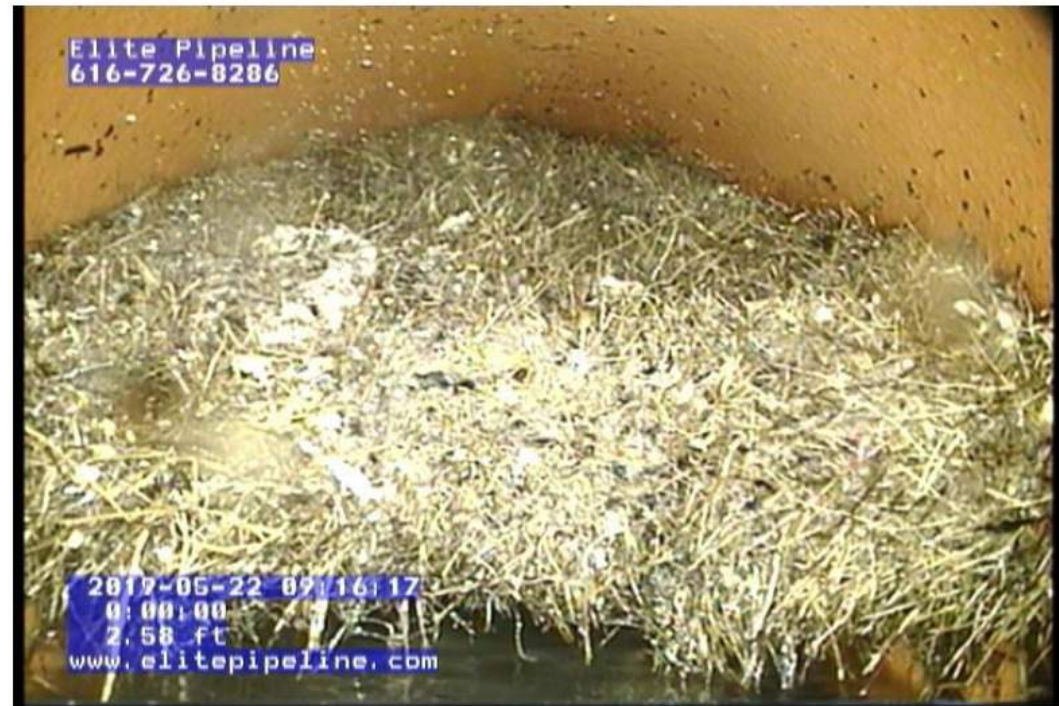
Roots (Ball Barrel) – 257' Downstream MH 05654  
Drake Road

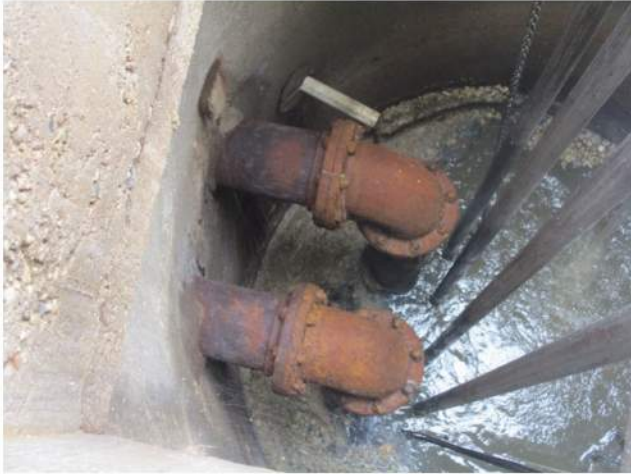
Corrosion of wet well piping

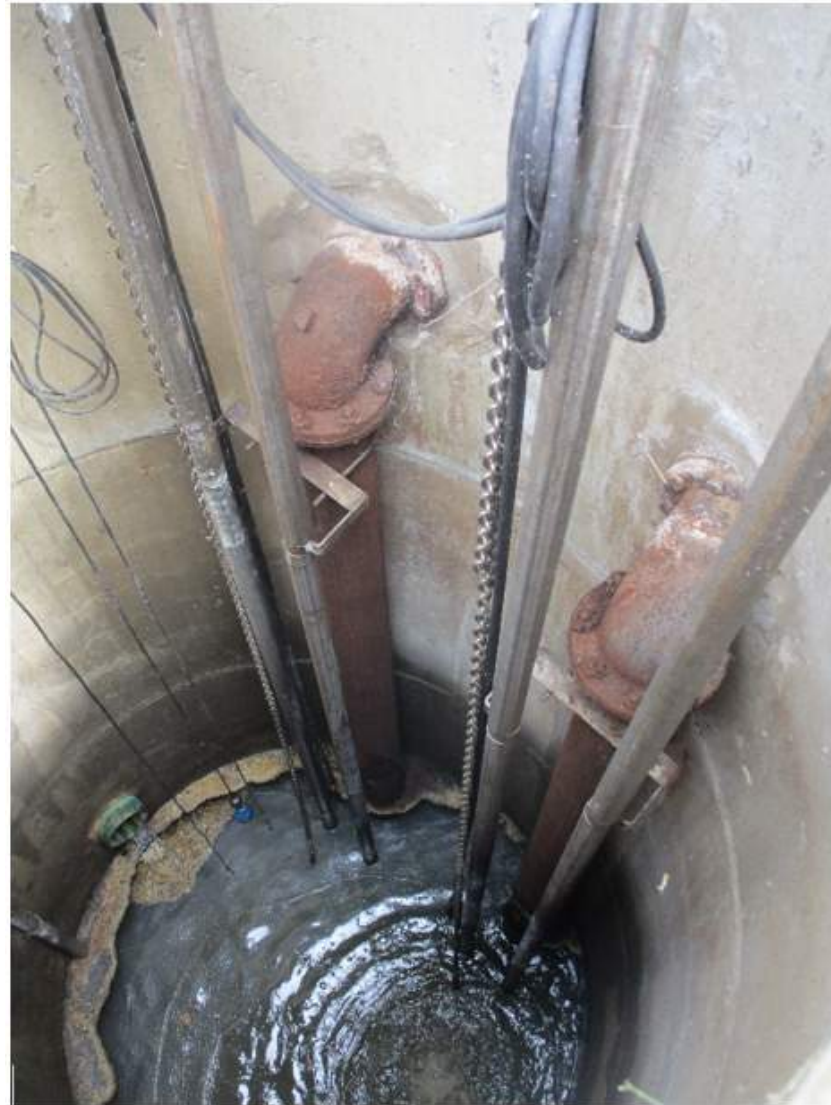
Corrosion of wet well piping, flanges grouted into wall

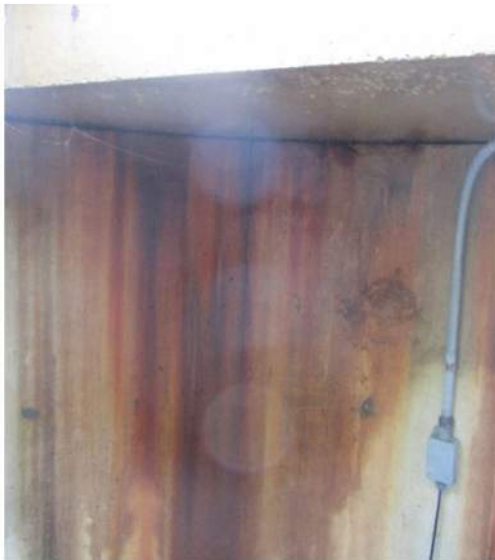
Signs of infiltration under valve chamber lid

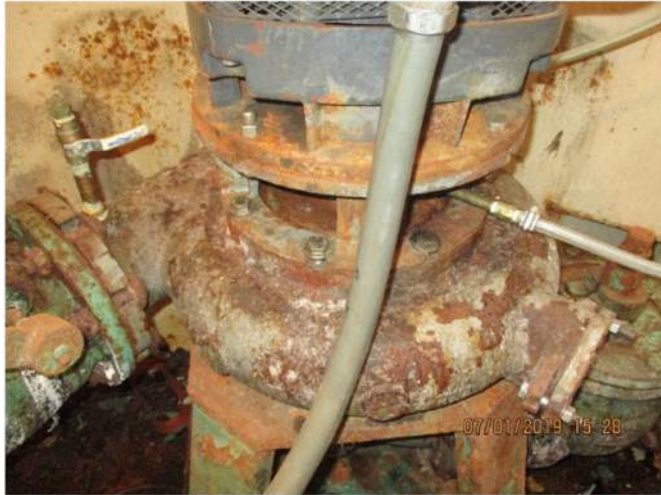
Corrosion of Pump No. 2

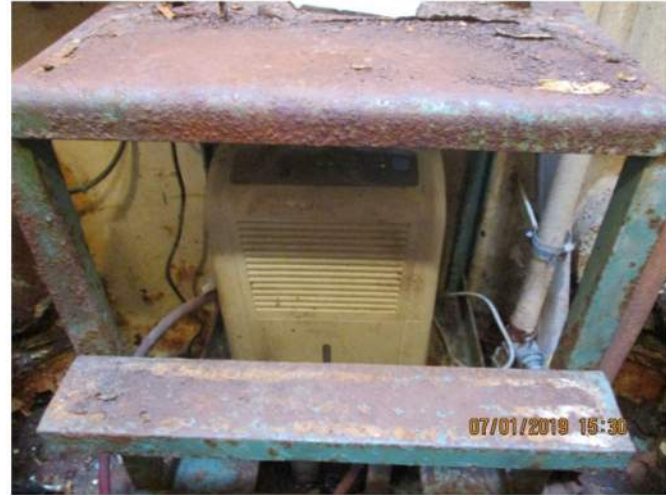
Dehumidifier in poor condition

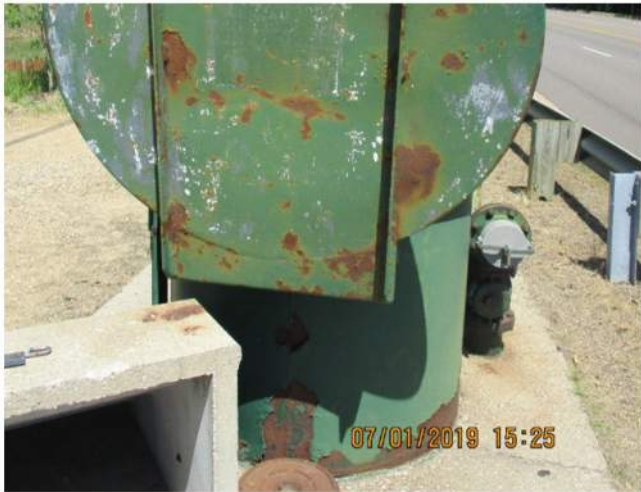
Corrosion of can exterior

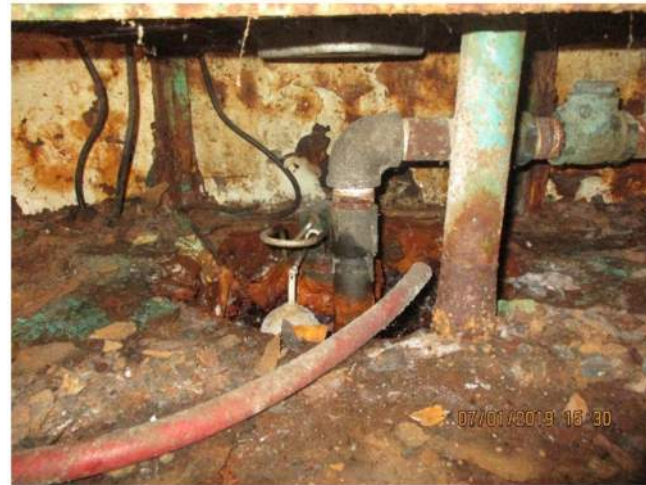
Corrosion of can floor, sump pump, and piping

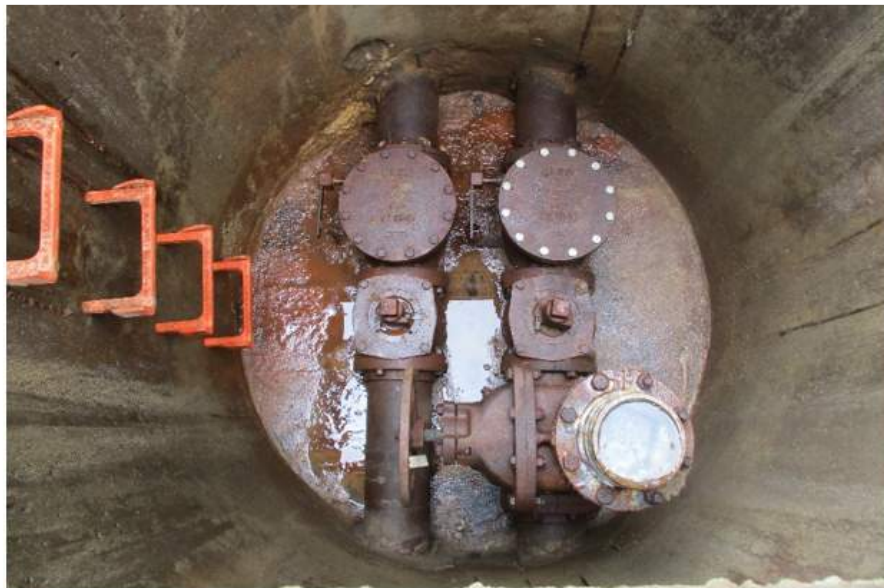
Corrosion of valves and piping in valve chamber

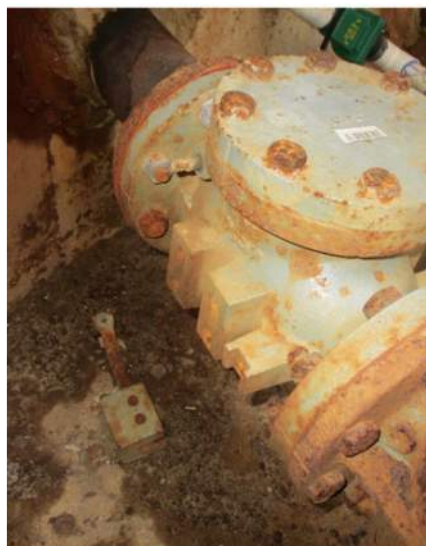
k valve lever arm, corroded valves

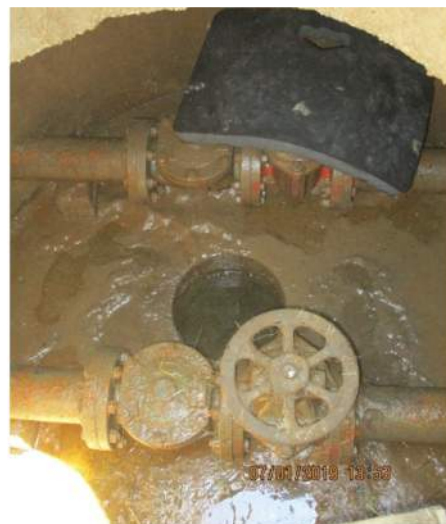
Corrosion of valves and piping, accumulation of solids in valve chamber

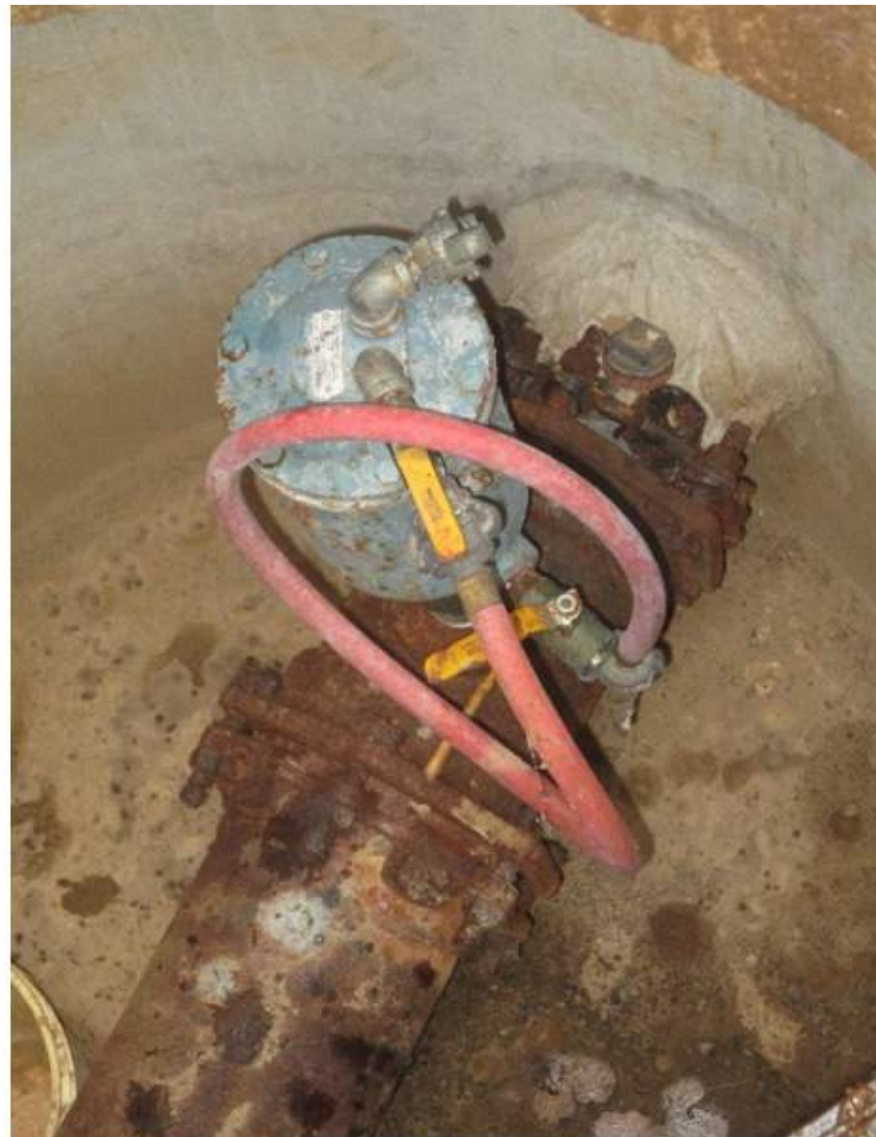
Corrosion of air release structure piping, valve in poor condition

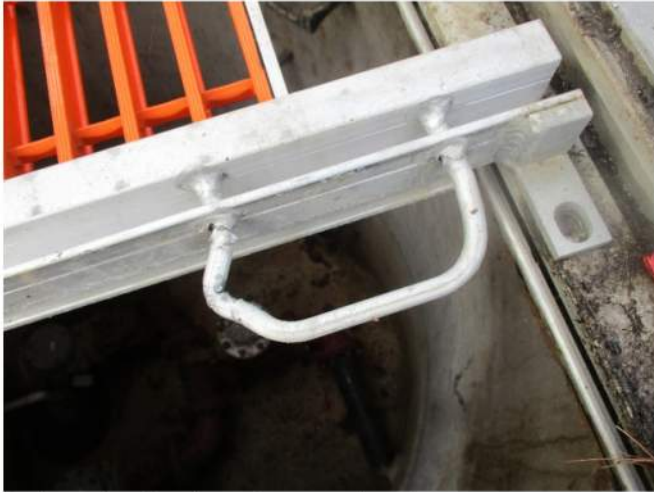
Broken valve chamber safety grate handle

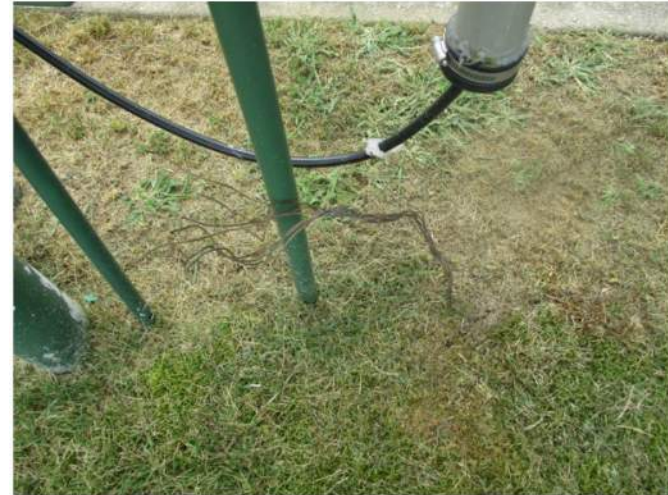
Grounding electrode not connected to control panel

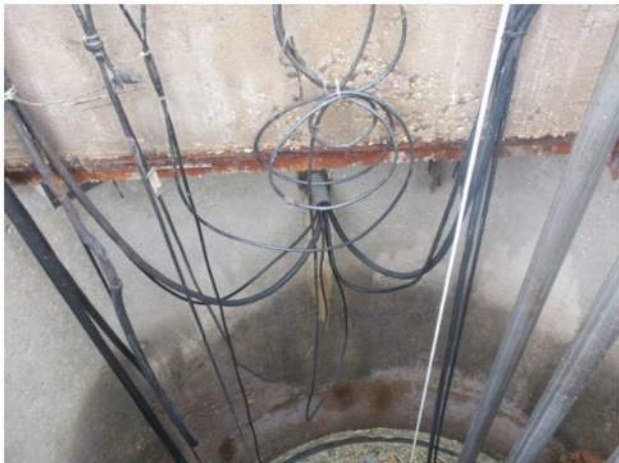
Intrinsically safe instrumentation cables in same conduit as pump cables

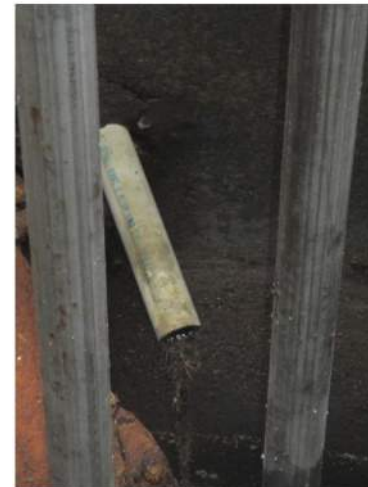
Valve chamber drain pipe partially clogged with roots
